Re: Marion Town House Existing Conditions Assessment

EXISTING CONDITIONS ASSESSMENT

JANUARY 14, 2011

Marion Town House

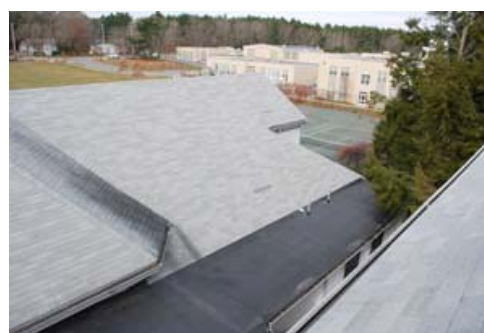
3/X-1.5 - Rubber roof on link

The rubber roofs appear to be relatively new and are in generally good condition.

Regular semi-annual inspections are required for good long term roof maintenance. A regular fall and spring inspection would be a minimal first step.

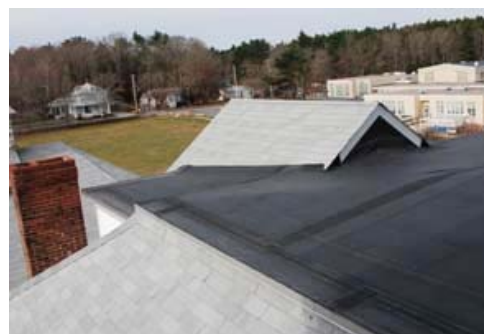
4/X-1.5 - Rubber roof (upper) & asphalt strip shingle (lower & dormer)

The asphalt shingles are grey single-tab strip shingles, 3'-0" long. They are in generally in good condition, most appear less than 15 years old. The tower roof (photo 2) seems to be newer than the rest perhaps within the last five years.

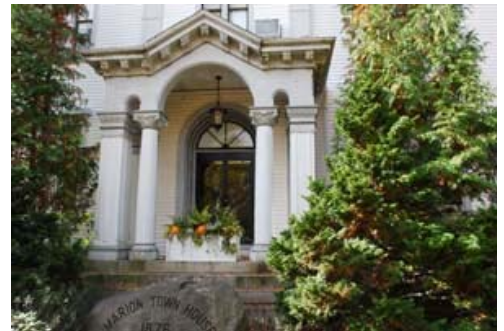
5/XL-1.1 - Historic main entrance

Virtually all of the original wooden exterior doors have been replaced with fully glazed black anodized aluminum store front units. However, the original wooden half-round four-light transoms still remain in place.

While certainly functional, both the size and design of the doors could be improved. A change in the size would help make the building more functional and a change of configuration would make the doors more sympathetic to the historic detailing of the building.

While the hardware appears to be accessible the large thresholds should be modified to conform with both the ADA and MAAB guidelines.

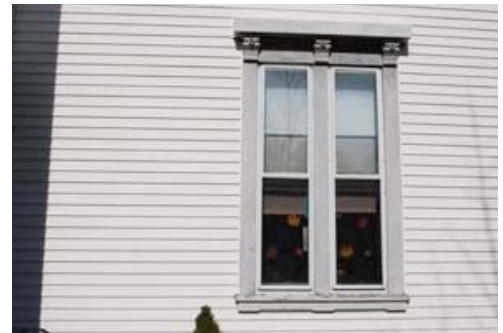
17/X-1.2 - Typical first floor window

The windows do not appear to have any weather stripping and many of them no longer lock well. They are a major source of air infiltration in their current condition.

The wood windows are in need of significant repair. This would include removing the glass, repairing, scraping, sanding and priming the sash, re-glazing the windows and finish painting the units. In addition, the windows should be completely weather-stripped and the weight balances either repaired or replaced with spring balances.

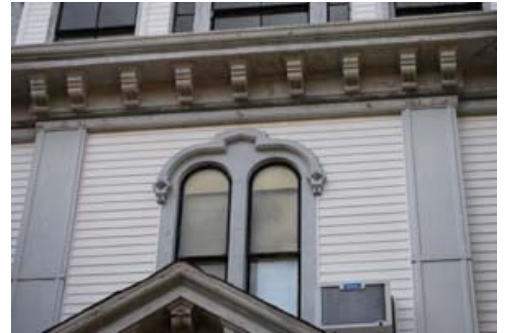
13/XL-1.2 - Historic detail & trim

The exterior wood trim is generally good condition and gives the entire building its distinctive architectural style. The handsome window and door casings, powerful eave brackets, quoins (currently covered by aluminum panning), and tower are hall marks of the Italianate Style of architecture that was so popular in the decades following the Civil War. While the paint finish is in poor to fair condition all of the visible trim is very good condition. The lower layers of paint likely contain lead and should be treated accordingly by skilled professionals.

It would be interesting to try to document the original colors to determine whether they could be used as part of a long-term restoration of the building. All of the trim should be carefully scarped, sanded, primed, caulked and painted with a high quality oil based primer and two coats of latex exterior paint.

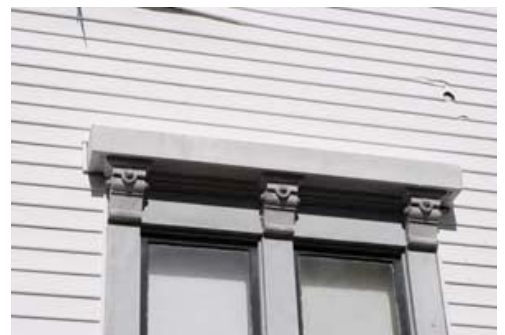
14/X-1.2 - Typical first floor window casing

The exterior head casings at the main building have been covered with aluminum panning, most likely to prevent water infiltration at the joint with the exterior wall. When this panning was installed, the historic details were concealed or removed.

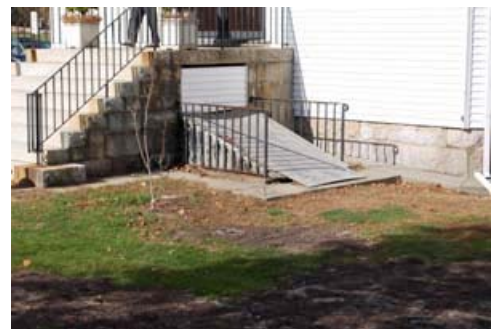
30/X-1.1 - Granite stair & foundation

The foundation is in very good condition (see the structural assessment which follows) with no signs of significant movement.

In select areas where water has infiltrated the structure, the mortar is damaged or missing entirely.

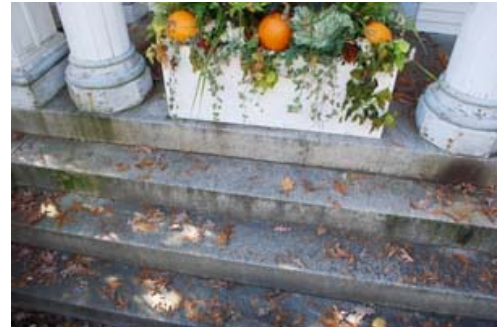
33/X-1.2 - Main historic granite stair

The handrails are also not what the code would require today, but seem to suffice. The handrails should be a larger dimension to comply with accessibility regulations and be located on both sides of the stair instead of just one as they are currently. The balusters at the hall stair have spaces more than the four inches currently required by code.

The joints between many of the stones have eroded and require repointing or new caulking to limit water penetration

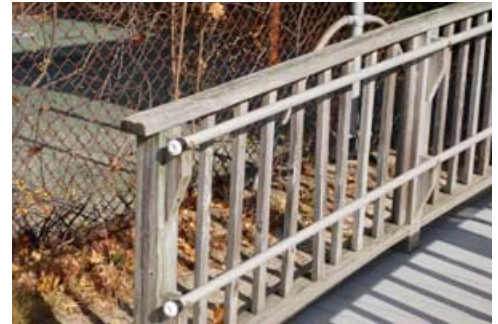
37/XL-1.1 - Typical railing detail at ramps

The accessible ramps along the north side of the building are made of pressure-treated posts, stringers and railings with composite decking. The ramps do not appear to be more than 15-20 years old and are in very good condition. They do not meet some of the dimensional requirements of the current code – size of turning platforms must be a minimum of 60" in both directions. The spacing between balusters is also larger than the four inches currently allowed.

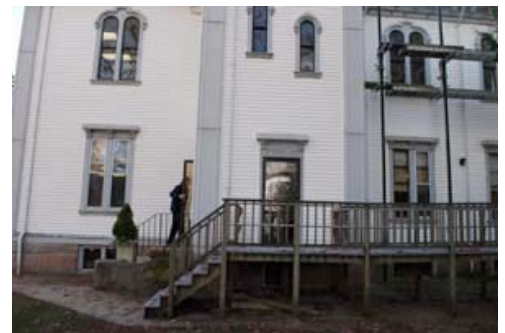
38/XL-1.1 - Accessible ramp to lower level at north side of building

The ramps serve only two doors on the north side of the building, one at each first floor level and can only be accessed from the northeast corner of the west parking lot. The ramps are quite long and can be quite slippery in the winter.

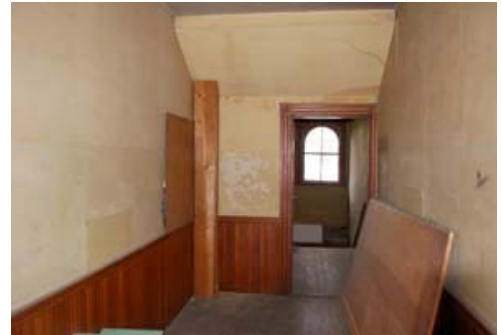
45/X-1.4 - Painted plaster walls at third floor

The original plaster finish of the interior walls in the Town House is generally in very good condition. There are a few select areas where water has damaged that plaster (photo 45), but in the vast majority of the building the plaster has a well-maintained paint finish. Only the third floor that has not been used very recently has large cracks and areas of failed plaster where only the wood lath remains.

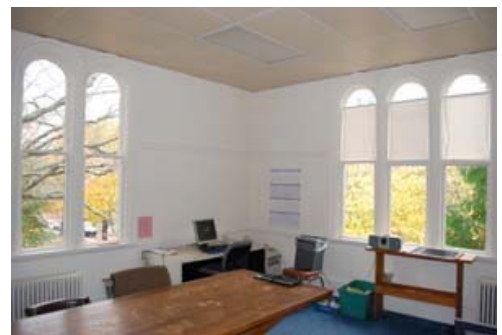
46/X-1.3 - Painted plaster walls at second floor office

The rest of the building has been very well maintained and the painted walls are in good condition of their age (photo 46). On the first floor some of the walls may be in worse condition but it is difficult to know with certainty since they have been covered with plywood paneling (photo 47). There are several newer interior partitions in the upper hall that have a painted gypsum board finish (photo 48) and these are also in very good condition.

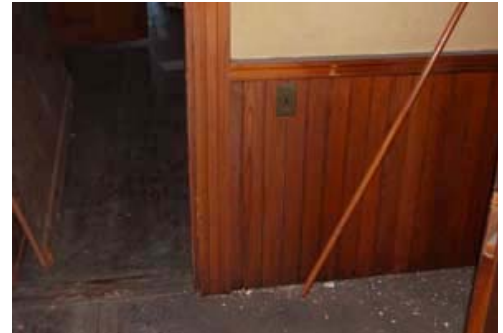
49/X-1.4 - Wood strip floor at third floor hall

The building originally had wood floors (photo 49) and there are a few locations, the third floor and stairways, where those floors are still visible (photo 51). Since the conversion from a school to an office building, the floors have been covered with carpet to “quiet” the spaces (photo 52). Vinyl tile has been installed in the toilet rooms.

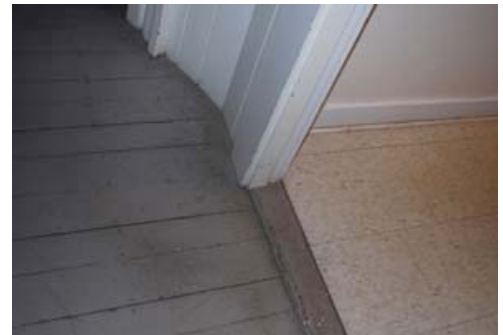
51/X-1.3 - Original painted wood plank floor at second floor with vinyl tile in toilet room

So long as the building maintains its office function carpet seems the best appropriate finish. Routine vacuuming, cleaning and shampooing will increase the life of any installation. The painted finish visible in the stair ways (photo 51) while attractive requires higher maintenance and probably should be avoided.

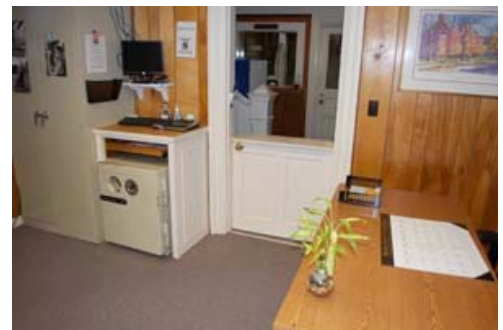
52/X-1.2 - Typical carpeted floor

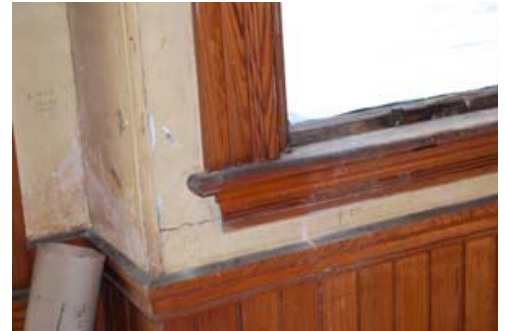
53/X-1.4 - Clear finished wood window trim & wainscot at third floor

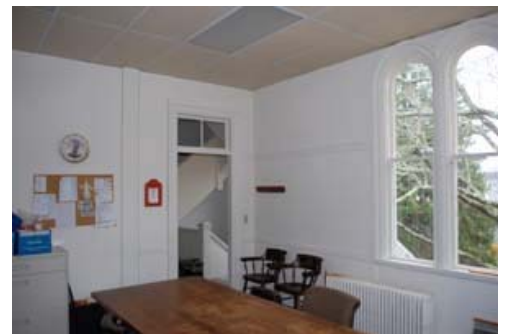
54/X-1.3 - Painted interior wood trim typical, shown here at second floor office

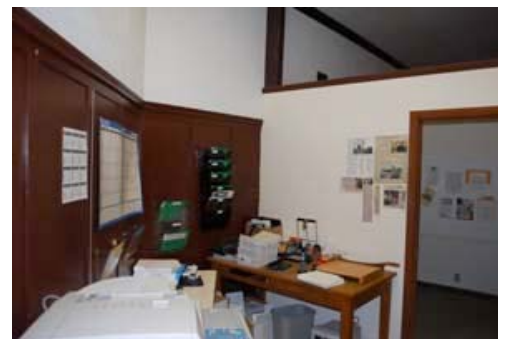
55/X-1.2 - Clear finished trim at upper level assembly hall

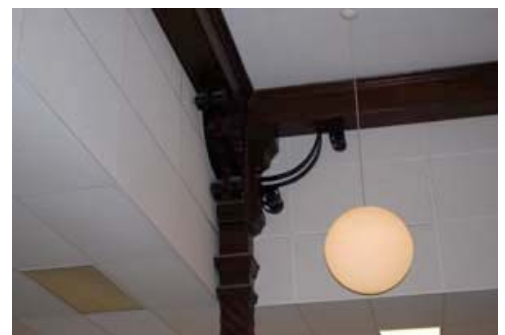
56/X-1.2 - Clear finished decorative column at assembly hall

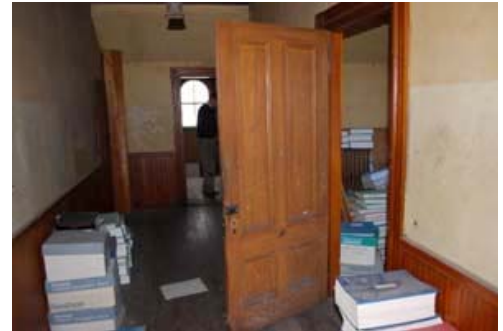
57/X-1.4 - Clear finished 4-panel interior wood door

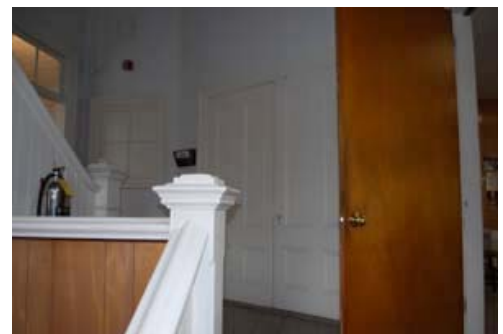
There are also several hollow core flush wood doors (photo 58) sprinkled throughout the building. Many doors currently have thresholds that exceed the limits of current accessibility regulations. These should be modified as necessary to remove these barriers throughout the building.

58/X-1.3 - New clear finished flush wood door & double 4-panel painted wood door

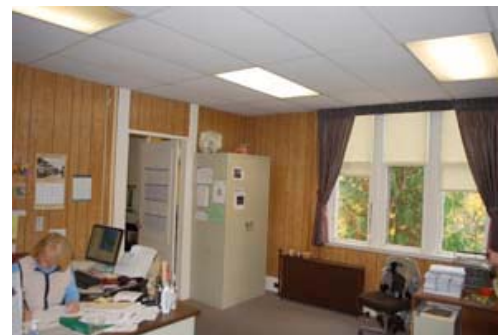
59/X-1.3 - 4-panel interior wood door

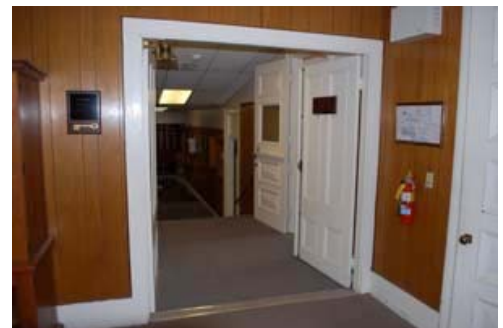
60/X-1.2 - 4 & 5-panel interior wood doors

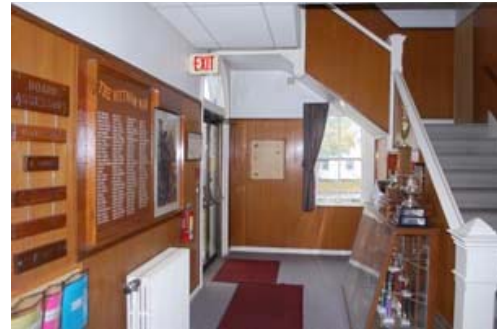
The basement, second and third floors are only reachable by stairs (photos 61 & 63), so those floors are presently inaccessible. The public counters at the building department, assessor and the town clerk are not fully accessible either. These should be modified as part of any interior renovation.

61/X-1.2 - Inaccessible south tower door & second floor stairway

The installation of an elevator should also be considered to provide access to the basement, second and third floors. Given the existing plan the likely location would probably be at the link between the main building and hall addition. This will require further study to minimize its impact on the historic qualities of the building.

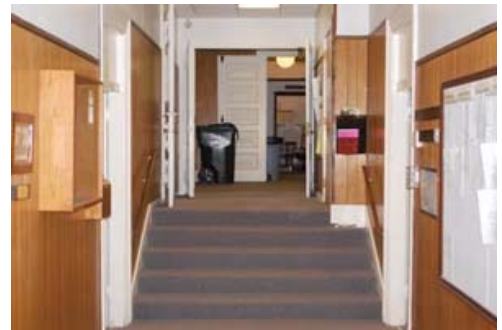
62/X-1.2 - Five riser change in elevation from lower to upper levels on first floor

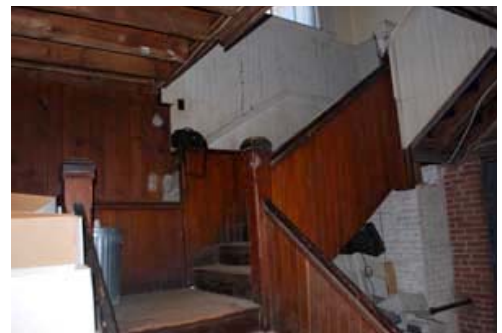
63/X-1.1 - Inaccessible basement stair

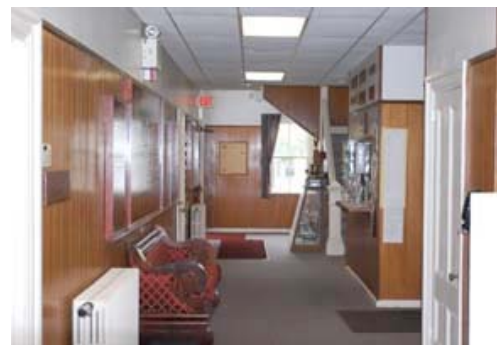
64/X-1.2 - Counter @ Building Department

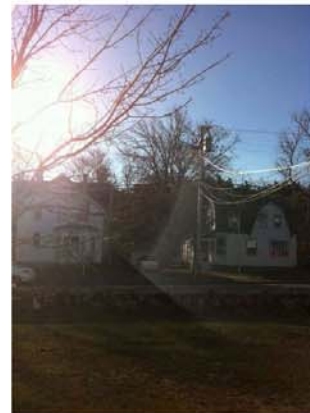
E2 Overhead Electric Service Lateral

- The electric service runs overhead to the building. The service equipment is located in the basement.

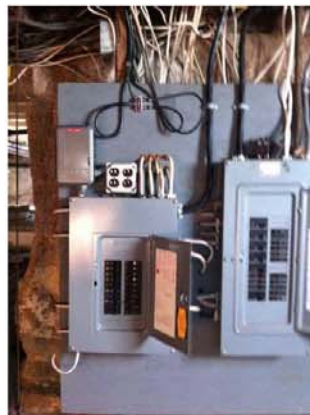
E3 Older Lighting and Power Panels

- Older lighting and power panels are circuit breaker type and are rated at 120/240 volt, 1Ø, 3wire. The panels are located in the basement on opposite wall of service equipment and are in poor condition.
- The existing panelboards are from various manufacturers.
- The service capacity is approximately 320 amps or 76.8 kW, yielding approximately 3.7 watts per square foot. The service will not accommodate an elevator addition.

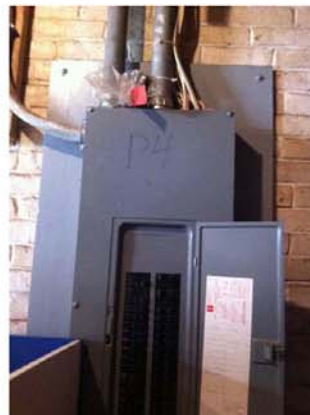
E4 Older Lighting and Power Panels with "SER" Server Cable

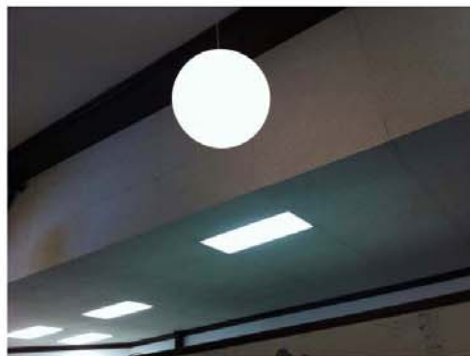
E5 Existing Fluorescent Lighting

- Existing lighting consists mostly of fluorescent troffers with acrylic lenses.
- Mechanical spaces in the basement have mostly incandescent keyless fixtures present. Fluorescent strips have been added near equipment to provide better illumination.
- Lighting in corridors is similar to offices. Fluorescent 2x4 fixtures have been used with acrylic lenses.

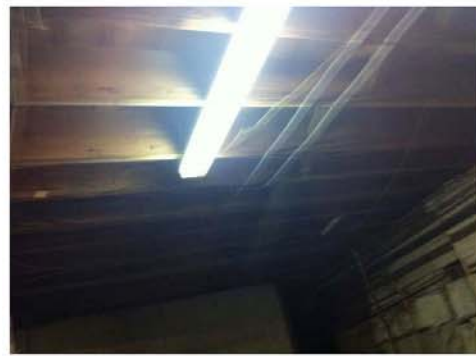
E6 Fluorescent Strip at Mechanical Spacers

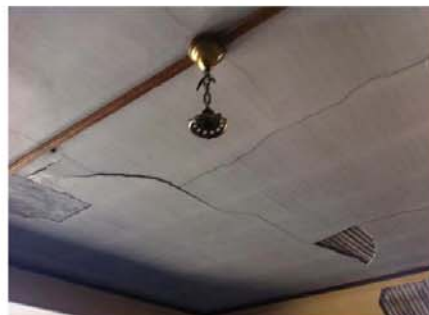
E7 Light Fixtures on 3rd Floor

- The third floor has incandescent fixtures installed in some areas. Some rooms just have exposed wiring where fixtures were previously installed.
- The Annex Selectman Meeting Room has globe fixtures installed. The lighting level appears low.

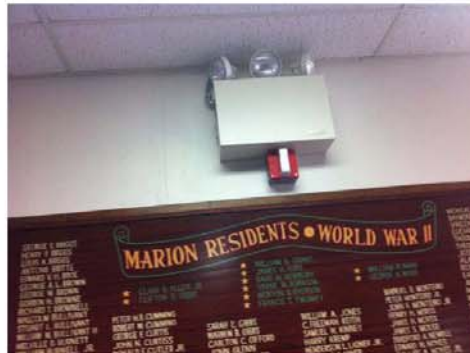
E8 Typical Emergency Battery Unit

- Emergency lighting throughout the space includes battery units. There is no emergency generator present. The area covered appears adequate for the First and Second Floor. The Third Floor does not have adequate coverage.
- Exit signs on First Floor are illuminated as required by Code.

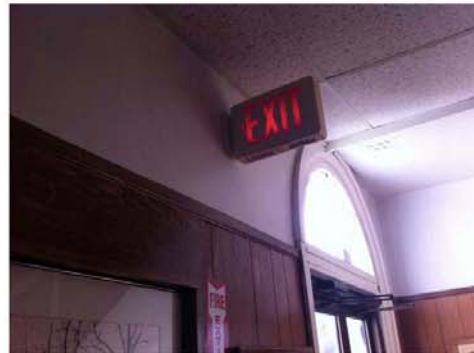
E9 Lighted Exit Sign

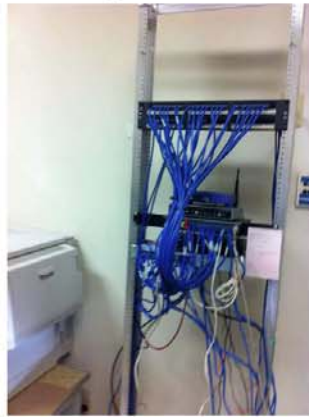
- There is an existing Head End located on the Second Floor. The room does have dedicated cooling. The Head End equipment includes a rack with 48 port patch panel and (2) 24 port switches along with cable modem and firewall.

E13 Head End Equipment

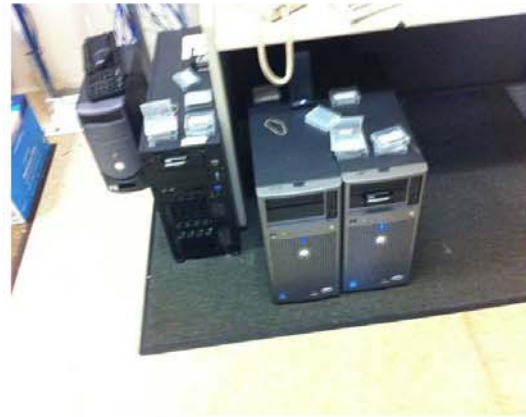
E14 Servers at Head End Room

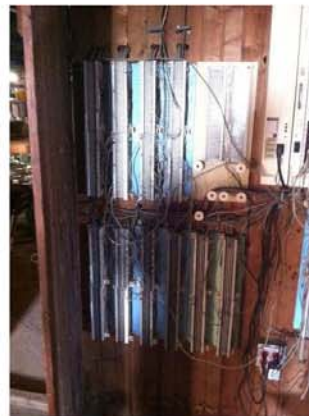
- There is a Verizon demarcation in the basement located near the electrical service equipment. The demarcation serves the Marion Town House and Library.
- There is a telephone switch in the basement. The telephone switch appears to serve the Marion Town House only.

E15 Telephone demark at Basement

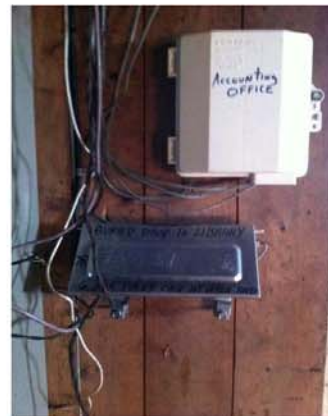
E16 Telephone Circuits to Library
